# NICKEL SMELTER INTERCOOLER REFURBISHMENT

ID: 10316

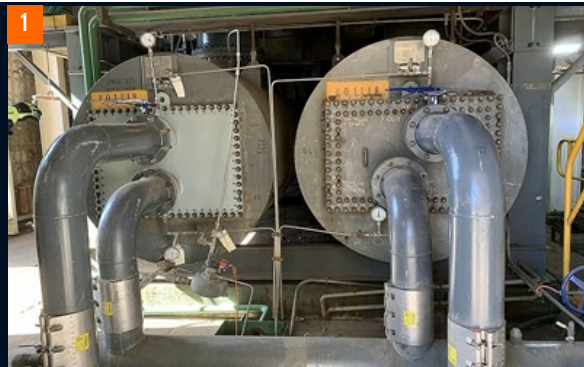
Two intercoolers at a nickel smelter had suffered severe corrosion, resulting in a near-total loss of coating integrity and requiring refurbishment. The corrosion assessment identified extensive coating failure and significant corrosion of the main shell and internal components, including the cooling system support rails.

1. Nickel smelter intercoolers in need of repair
2. Significant corrosion of the main shell and internal components.
3. Pit filling and metal repairs undertaken with Belzona 1511.
4. Final application of Belzona 1523 applied to the intercoolers.
