# 151 PIPE ELBOWS REFURBISHED AND PROTECTED AGAINST ABRASION USING 1.5 TONNES OF BELZONA 1812

ID: 10319

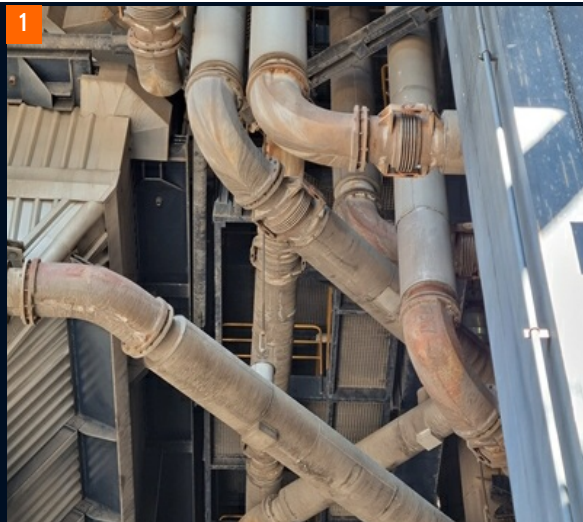
1. Pipework leading from the coal mill to the burners.
2. Pipe elbow showing remnants of the previous Belzona 1812 application.
3. One of the most severely damaged pipe elbows before application.
4. Pipe elbow after application of Belzona 1812.

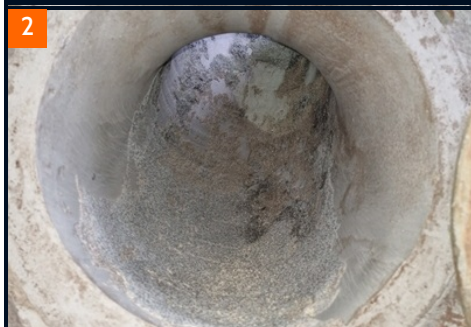
The customer selected Belzona primarily due to their positive previous experience with the system. As shown in Picture 2, after a minimum of 12 years in service following the original application, remnants of the previous Belzona 1812 lining were still present on some pipe elbows and could not be removed by abrasive blasting. After two years in service following the 2024 application, feedback from the customer confirmed that no external issues were observed during the annual turnarounds in 2025 and 2026. As a result, dismantling and detailed internal inspection were not required.

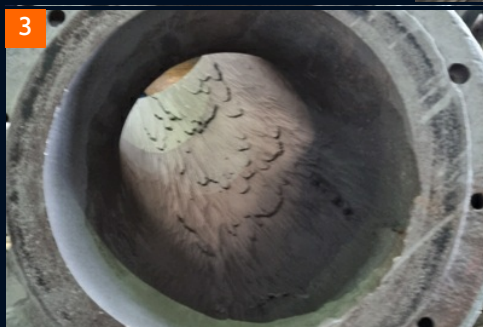
The firing system at a coal-fired power plant comprises six coal mills, from which pulverised coal is transported through pipework to 24 burners. The system includes 151 pipe elbows, together with additional pipework components, which are exposed to severe abrasion caused by coal dust particles in transit. This abrasion resulted in loss of pipe wall thickness, creating a risk of breakthrough, unplanned production shutdowns and serious safety concerns, particularly because coal dust is flammable and potentially explosive.

The application was carried out in accordance with Belzona Know-How System Leaflet SHM-8. The surfaces were abrasive blasted, degreased and dedusted in accordance with the Belzona 1812 Instructions for Use. Belzona 1812 was then applied using Belzona application tools to rebuild the worn areas and provide an additional 3 mm layer of abrasion protection.
