# ABRASION PROTECTION OF SLAG DOSING CYCLONES AND PIPEWORK AT A CEMENT PLANT WITH BELZONA 1813

ID: 10322

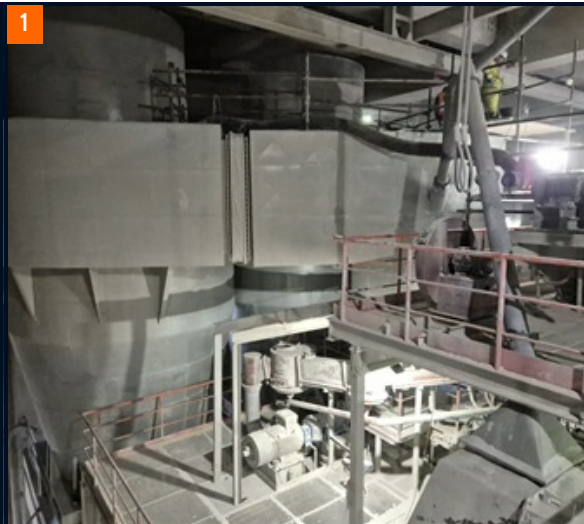
Ground slag added to cement clinker was causing severe abrasive wear inside the separator cyclones and associated pipework. Continuous material flow gradually reduced the steel wall thickness, increasing the risk of breakthrough and unplanned shutdowns between scheduled annual maintenance intervals.

1. Slag dosing cyclones and connected pipework from the outside.
2. Customer-repaired area with welded steel plates before Belzona application.
3. Belzona 1813 application in progress
4. One affected area after Belzona 1813 application.

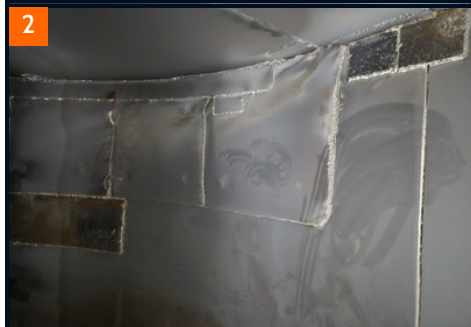
The customer required a reliable sacrificial lining to control abrasion and extend the service life of the equipment until the next planned annual turnaround. Prior to the Belzona application, the customer repaired the most damaged and perforated areas in-house by welding steel plates over the affected sections. Due to the abrasive nature of the conveyed slag and a maximum operating temperature of 120°C, Belzona 1813 was selected as the most appropriate solution. In total, 500 kg of Belzona 1813 was used to protect the most exposed areas.
