# BELZONA REPAIRS AND PROTECTS THE TANK FOUNDATIONS OF NUMEROUS STORAGE TANKS

ID: 10324

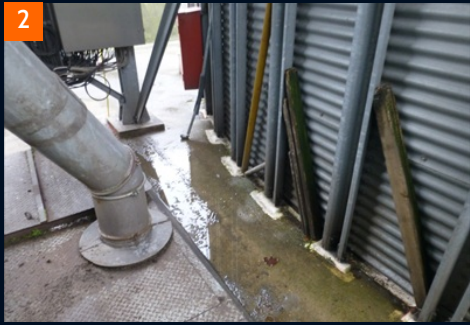
The concrete foundation of the storage tank had structural issues. Because the concrete was highly porous and sloped towards the tank, water regularly collected around the base and soaked into the old concrete. Over time, this moisture found its way into the tank, causing the stored seed material to clump together into a hard, concrete-like mass. This aggressive material then started attacking the inside surfaces of the tank, leading to increasing damage.

1. Tanks before the application
2. Condition of the problem areas
3. Application of Belzona 4111
4. All tank foundations repaired and protected with Belzona 3111

In 2005, the first tank foundation was repaired with Belzona 4111 and protected with Belzona 3111. Twenty years later, in 2025, the customer found that the products were still well bonded to the substrate. However, increasing moisture penetration and continued deterioration of the old concrete had made the underlying structure unsuitable for long-term service.
