# BELZONA SUPER WRAP II SAVES A SEVERELY CORRODED MANIFOLD

ID: 10325

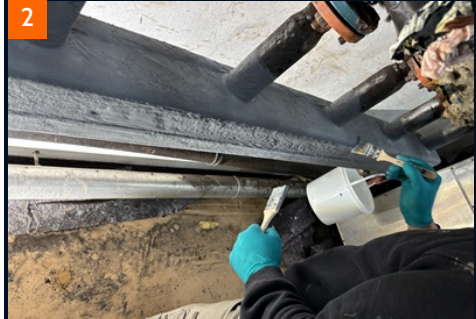
The manifold was insulated but had not been inspected for many years. During an inspection, severe corrosion was discovered, with deep pitting in several areas and even through-wall holes that were causing water leaks. An urgent repair was required to stop the leaks, restore the strength of the manifold, and provide long-term protection.

1. Corroded manifold
2. Substrate repaired using Belzona paste-grade materials
3. Start of the Super Wrap II application
4. Completed repair
