# BELZONA BONDS STEEL PLATES ONTO SCRAPER TRACK

ID: 10326

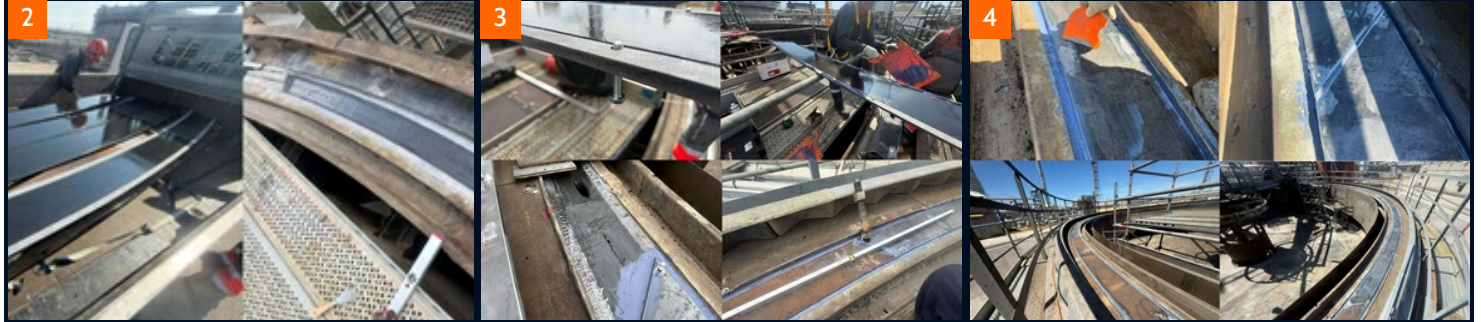
In a process vessel used in the refining industry, the scraper track surfaces had become heavily worn after years of mechanical loading. In some areas, the tracks had worn through completely, affecting both the safe operation of the equipment and the performance of the scraper system. The condition required a repair solution that could reliably restore the load-bearing capacity and worn running surfaces without the need to replace the existing structure.

1. Damage before and after surface preparation
2. Prepared steel plates
3. Fitting and bonding the steel plates
4. Filled bolt holes and completed repair

Following a technical assessment and the development of a repair plan, custom-fit replacement steel plates were fabricated, prepared, and coated for corrosion protection. At the same time, the existing track surfaces were cleaned, abrasive blasted, and protected against corrosion.

Before bonding began, the threads of the adjustment screws were coated with Belzona 9411 release agent to ensure they could be removed afterwards. Once the prepared steel plates had been aligned, Belzona 7311 structural adhesive was applied to the designated contact surfaces. The plates were then lifted into position using a crane and lifting magnets, accurately aligned, and bonded to the existing track surface.

The joints between the plates were installed with a controlled gap and also filled with Belzona 7311. After the adhesive had fully cured, the adjustment screws were removed and the remaining areas were filled and smoothed with Belzona 1121.
