# BELZONA REBUILDS AND PROTECTS CORRODED MARINE TAILSHAFT AGAINST SEAWATER CORROSION

ID: 10329

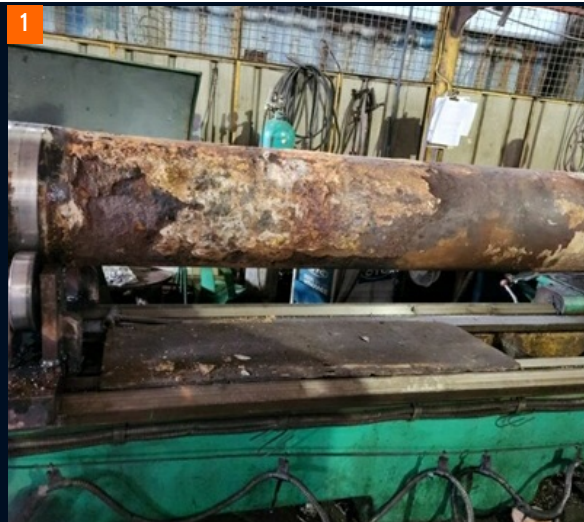
The marine tailshaft exhibited severe corrosion and surface deterioration after prolonged exposure to seawater, compromising the shaft surface and increasing the risk of accelerated wear and premature seal failure. The damaged areas required restoration to recover the original dimensions and provide long-term protection against further corrosion before the shaft could be returned to service.

1. Severe corrosion and surface deterioration on the marine tailshaft prior to restoration.
2. Overall condition of the corroded tailshaft before repair.
3. Tailshaft prepared by mechanical cleaning prior to Belzona application.
4. Belzona 1111 (Super Metal) restoration completed and protected with Belzona 1321 (Ceramic S-Metal) coating for long-term corrosion resistance

The tailshaft was mounted on a lathe machine to allow controlled rotation throughout the repair process. Corrosion products and deteriorated material were removed by mechanical surface preparation, followed by thorough cleaning and degreasing to achieve a suitable substrate. Belzona 1111 (Super Metal) was applied to rebuild the corroded areas and restore the shaft profile. After machining and achieving the required surface finish, Belzona 1321 (Ceramic S-Metal) was brush-applied as a protective coating to provide long-term resistance against corrosion and environmental exposure.
