# BELZONA KEEPS CUSTOMERS ROLLING

ID: 1033

Tire repair

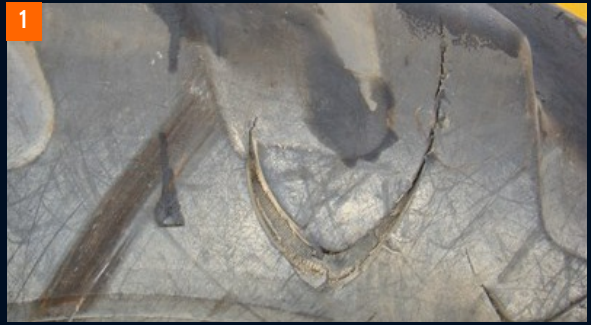
After the rental was returned they saw the damage and needed a repair right away, knowing the unit was booked to go right back out.

1. Damage to the tire
2. After the roughing surface conditioned
3. Belzona 2311 completed repair
