# BELZONA CUSTOM ENGINEERED SOLUTION REDUCES SF<sub>6</sub> EMISSIONS FROM CRITICAL 132KV JUNCTION

ID: 10330

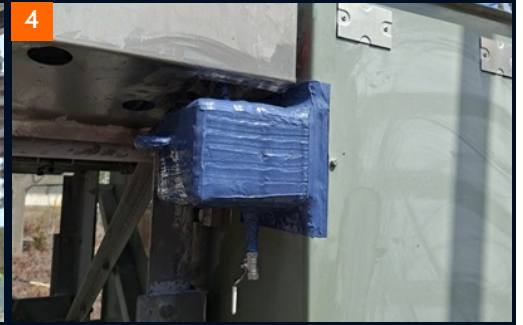
Significantly reduced, and where possible eliminated, SF<sub>6</sub> gas emissions from the leaking junction.

1. Previous repairs had been attempted and failed due to unusual positioning
2. A bespoke containment box was fabricated to fit around the junction
3. Belzona 7311 was injected into the void space to completely fill the cavity and eliminate any trapped air
4. Significantly reduced, and where possible eliminated, SF<sub>6</sub> gas emissions from the leaking junction.
