# REPTECH REPAIRS AND RECOATS A HOT WATER PROCESS TANK WITH BELZONA

ID: 10334

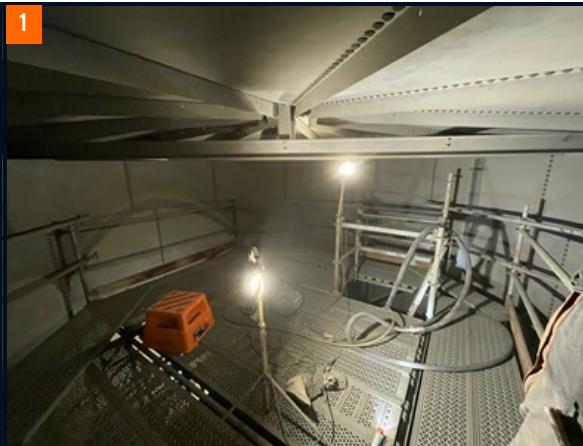
1. Steel grit was used to ensure efficient removal of the original glass-flake coating and hot air was pumped into the tank to ensure favourable ambient conditions overnight, holding the blast at SA 2½
2. Holes and pitting were repaired with Belzona 1111 (Super Metal), Belzona 9341 and doubler plates.
3. The first coat of Belzona 5892 white was spray applied; complex geometries received a Belzona 5892 Grey stripe coat the following morning (well within the overcoat window). As soon as this was completed a topcoat was sprayed in B5892 Grey.
4. Finally, the scaffolding was removed, and the process was repeated for the tank floor, ensuring that the previously coated walls were protected.
