# BELZONA REHABILITATES CONCRETE DISTRIBUTION CHAMBERS IN AN ODOUR-COVERED INLET CHANNEL

ID: 10338

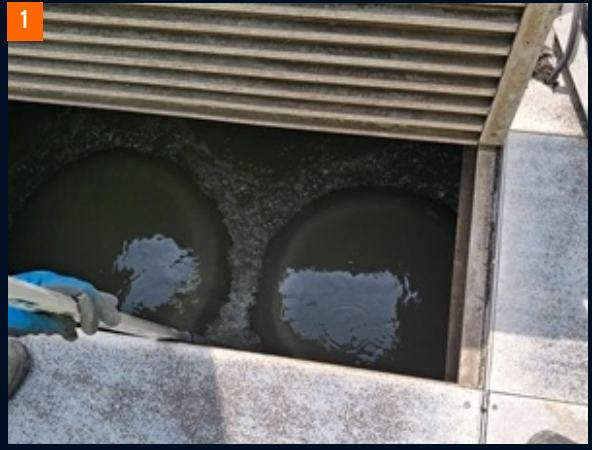
1. The tanks were covered as part of an odour control strategy
2. Deterioration of the tanks had continued under the covers and required a repair solution
3. damaged areas were then rebuilt using a combination of bulkfill material and Belzona 4131 Magma Screed
4. The repairs provided a durable, chemically resistant repair capable of withstanding the harsh wastewater environment.

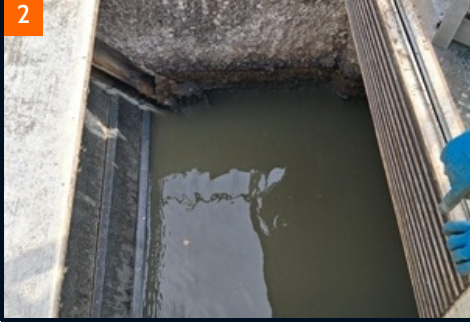
Two concrete distribution chambers within an inlet channel were exhibiting significant deterioration in the gas phase area following prolonged exposure to a corrosive wastewater environment. The chambers had been covered as part of an odour control strategy; however, deterioration of the concrete substrate had continued beneath the covers.

The damage had progressed to the point where the aggregate was exposed across multiple areas of the channel walls and surfaces. This level of degradation increased the risk of accelerated concrete loss, continued chemical attack, and reduced structural integrity if left untreated. Surveys identified an average substrate loss of approximately 20mm across both chambers, with repair depths extending up to 1.35m from the top surface of the chamber structure.
