# BELZONA HELPS TO STOP LEAKAGE

ID: 1036

Natural gas transporting pipe in power plant.

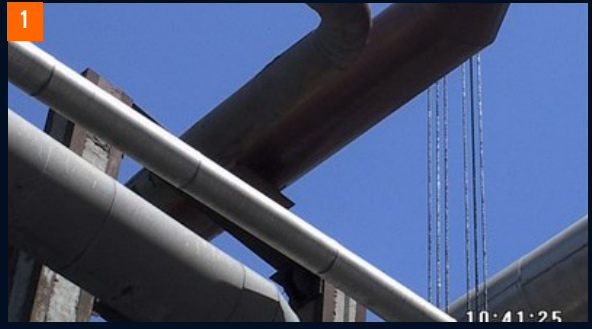
Leakage from the pipe caused by erosion/corrosion.

1. General view of the pipe to be repaired at high level more than 10 m above the ground
2. The hole revealed and surrounding area roughened
3. Reinforcement patch applied with Belzona 1221 pressed over the leak
