# BELZONA REPAIR OF CONVEYOR BELT

ID: 1037

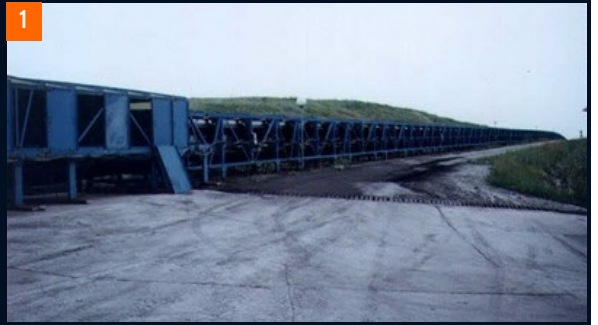
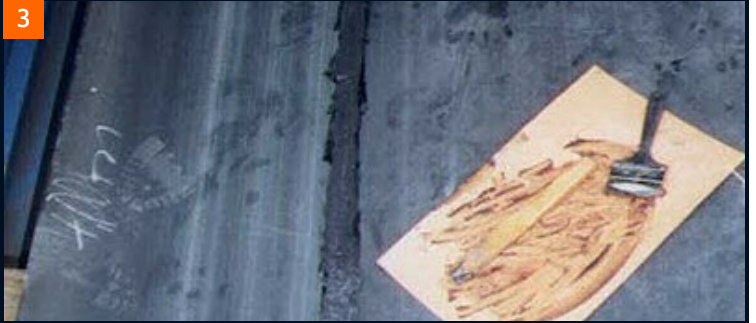
Mechanical damage on the protector/scrapper was exposing the metal reinforcement

1. View of the conveyor belt facility
2. Conditioning with Belzona 2911
3. Belzona 2311 used to rebuild the damage

The application was carried out in accordance with Belzona Know-How System Leaflet SHM-1.

Belzona 2311 (SR Elastomer)
