# BELZONA SEALS CEILING IN CHICKEN PLANT

ID: 1038

Ceiling joints at the Chicken plant

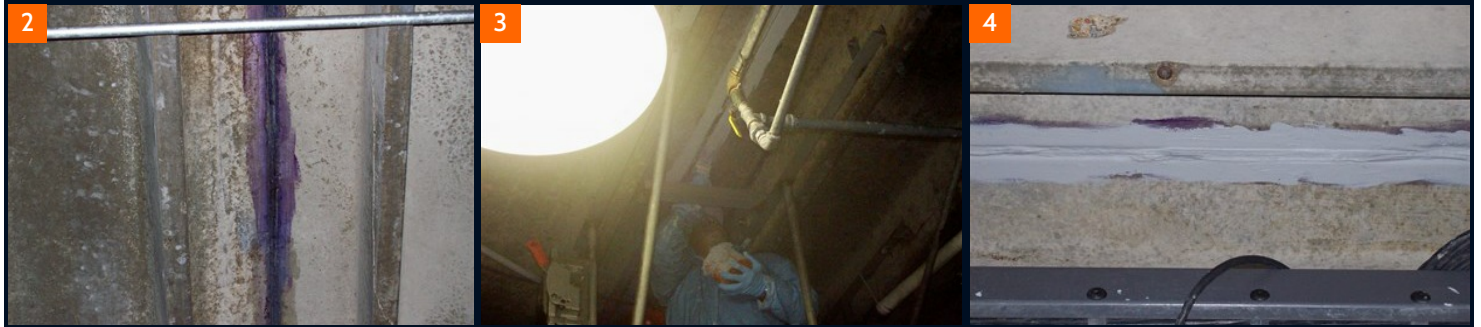
## PHOTOS

Carbon steel metal that is between the concrete prefabricated roof is rusting. The rust is falling onto the chickens and workers as they are being processed. The FDA came in and made them do a repair for the problem.

1. View of the joint with metal and concrete
2. Application of Belzona 3911
3. Applying Belzona 3111
4. Completed application

The work have to be done on the weekends. The only alternative was to use an epoxy concrete material to seal the joints and stop the rust from falling. Using the Belzona materials, we saved the plant \$50,000 and completed the project in four weekends, using 10 buckets of Belzona 3111.

Belzona 3921 (GSC Surface Conditioner)  
Belzona 3911 (PSC Surface Conditioner)  
Belzona 9311 (Reinforcing Sheet)  
Belzona 3111 (Flexible Membrane)
