# BELZONA SAVES REFINERY MILLIONS

ID: 1039

Amine regeneration tower operating above 250°F in an environment containing hydrogen sulfide and diglycolamine.

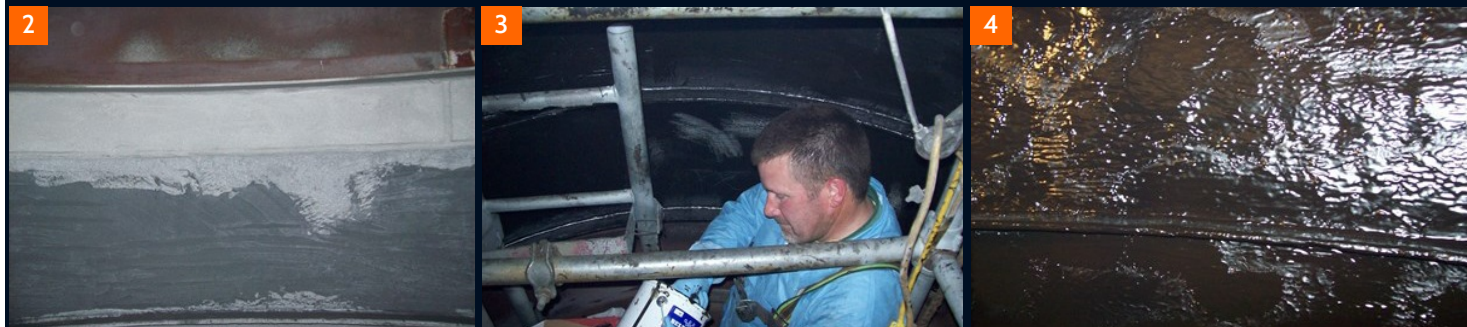
## PHOTOS

Corrosive process fluids and elevated temperatures create an extremely aggressive corrosion rate. If corrosion was not addressed, this vessel would have gone under its minimum wall thickness and forced a shutdown.

1. Abrasive blasted area
2. Repaired area with Belzona 1511
3. Application of Belzona 1591
4. Finished application after pinhole testing

Belzona® 1511 and Belzona® 1591 were applied in accordance with Belzona Know-How System Leaflet TCC-5.

Possible repairs included a Belzona solution or clad welding the affected area. The Belzona solution required less than \$40,000 of product and labor and was completed in three days. The clad welding would have required \$100,000 of product and labor and more importantly 10 days. Because daily lost production costs were \$9,000,000, the Belzona solution saved the refinery over \$63,000,000!
