# BELZONA 4811 REPAIRS TO CONTIMIX HYDROPULPER IN PAPER MILL

ID: 104

## PROBLEM

Basalt tile lining damaged and efficiency of machine impaired.

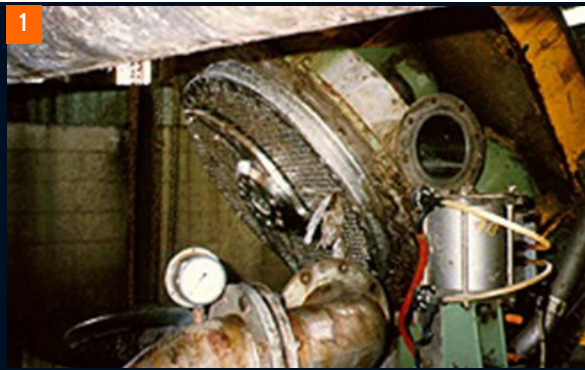
Contimix Hydropulper used to shred waste paper.

1. View of equipment with lid raised showing the pulping blade
2. The area of damaged tiles
3. Tiles re-bonded and grouted with Belzona 4811
