# 20 YEAR OLD BELZONA PUMP COATING

ID: 1041

Cooling water pump in a coal fired power plant.

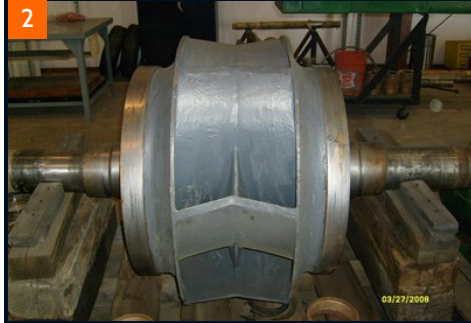
1. Cavitation Damage
2. Vanes in like-new condition
3. & 4 Closeup of localized cavitation damage. Note no corrosion creep under the coating

Inspection of the coated impeller showed it to still be in excellent condition with only small areas of cavitation damage. Coated pumps have proven themselves to far outlast uncoated ones, minimizing maintenance costs and downtime.
