# BELZONA CLEARS CLARIFIER PROBLEM

ID: 1045

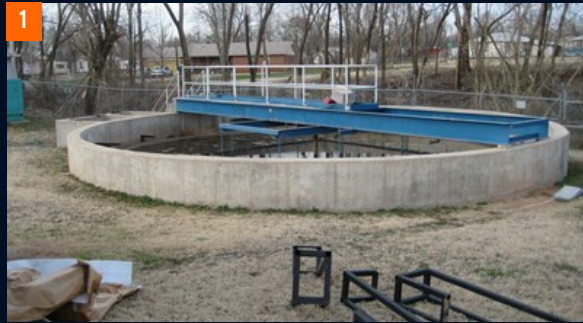
The aluminum shield on the clarifier extends 16 inches below the water line. This is the only one serving this small city.

1. Clarifier
2. Eroded Aluminum
3. Preparing the panels
4. Finished panels coated at the waterline on both sides

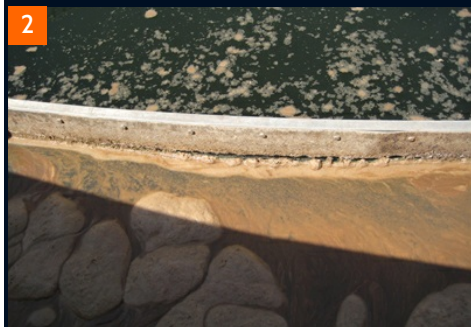
50% of the shield had been eroded away due to corrosion at the water line. A new skirt from the manufacturer would cost over \$15,000 and take unduly long to install.

Abraded new aluminum panels and coated with Belzona® 3921 and Belzona® 5811 in accordance with Belzona Know-How System Leaflet TCC-5. The panels were then bolted to the sound skirt eliminating need for complete replacement.
