# BELZONA LEAK SEALING EMERGENCY

ID: 1046

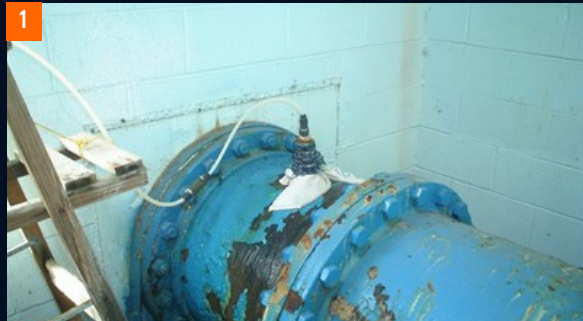
Line sprung a leak in an odd spot right next to a chemical injection nozzle which made the repair impossible with a normal clamp.

1. Rags over leak to keep the spray down
2. Sanding the leak and getting wet
3. Belzona 1291 applied and leak stopped
4. Belzona 1221 applied and leak fixed for good
