# BELZONA REPAIRS HEAVY DUTY SHAFT

ID: 1048

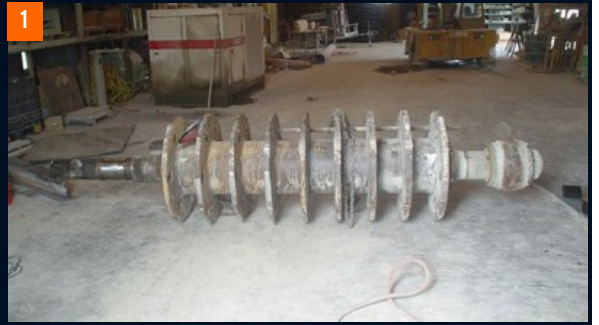
A bearing spun on the rock crusher at the cement plants quarry. Without the crusher back in service the entire quarry and cement plant would shut down.

Obsolete rock crusher from the 1950s. It has 300lb hammers on it. Used in the cement plants own quarry.

Rock crusherBelzona 1111 in split moldSanding shaft to sizeShaft ready to go to work
