# BELZONA FLOOR IS UP FOR HOT BATH

ID: 1049

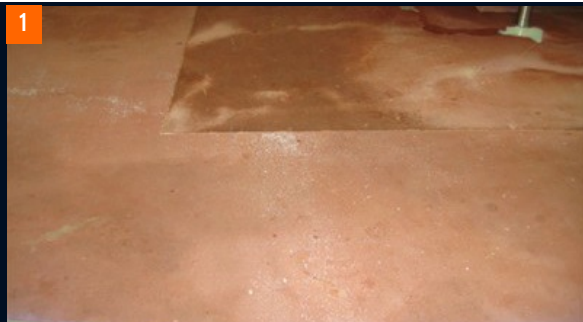
Existing floor covering badly deteriorated due to regular spills of hot CIP solutions. The dairy is only down from production on Saturday/Sunday.

1. Old floor
2. Surface preparation
3. Coating the floor
4. The rebuilt and finished floor
