# BELZONA REPAIR TO TURBO-PULPER

ID: 105

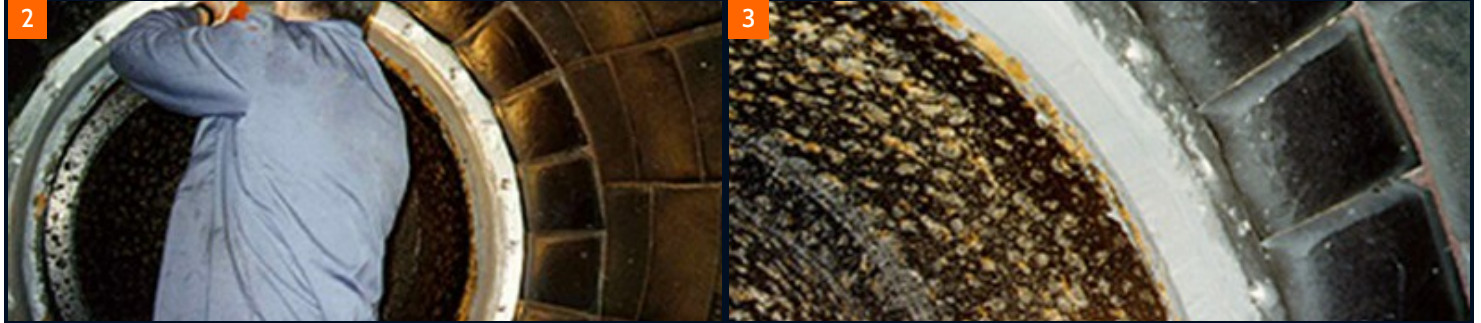
Erosion from pulp had worn away the sealing ring exposing the stainless steel bolts.

Stainless steel sealing ring inside turbo-pulper.

1. The degree of erosion on the sealing ring and bolts clearly evident
2. Application underway inside the pulper
3. Sealing ring and bolts completely encapsulated with Belzona 1111

Application was carried out in accordance with Belzona Know-How System TCC-5.

To remove sealing ring and replace would have taken a long time and interfered with production. Belzona application carried out within normal shutdown period and has prevented further erosion of the sealing ring and bolts.
