# BELZONA PUMP REBUILD

ID: 1050

Old split case pumps dating back to 1960.

Water Utility, Oklahoma USA

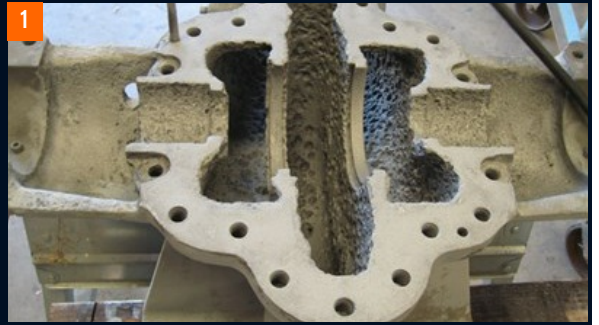
Many of the pumps have never been rebuilt and severe pitting was present. In some cases, it went almost through the casing.

1. Pump casing after grit blasting
2. Deep pitting repaired with Belzona 1311
3. First coat of Belzona 1341N applied
4. Second coat applied to complete the application

Application was carried out in accordance with Belzona Know-How System Leaflets CEP-1, CEP-3, and CEP-5.
