# OVERNIGHT FLOOR REPAIRS COMPLETED WITH BELZONA

ID: 1051

Floor around the case wash machine.

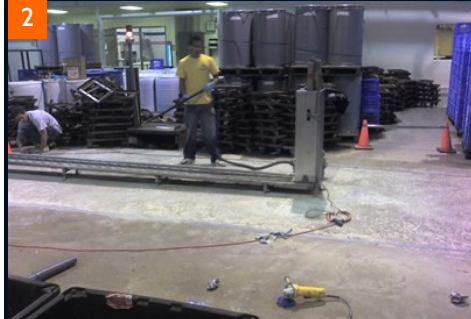
Floor was eroded and very slippery causing a safety hazard and slowing workers down. There is only an 8 hour window for this repair.

1. Dirty floor
2. Surface preparation
3. Applying tape & Belzona 4911 Conditioner
4. Squeegee coat of Belzona 4111 slurry & non-slip applied
