# BELZONA KEEPS VEHICLES MOVING

ID: 1055

Vehicle Testing Station Bratislava, Slovakia

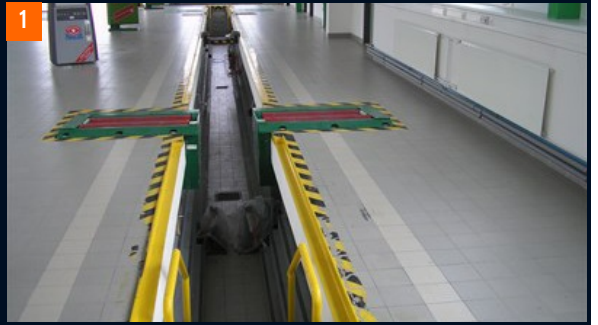
1. Vehicle Testing Station
2. Vehicle during the brake testing
3. 2 years in service

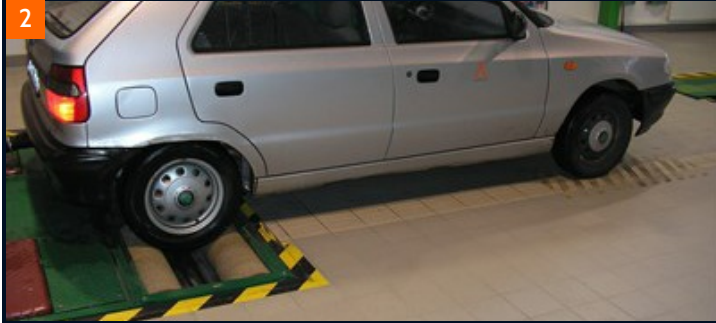
During the rain or snow, vehicles were slipping when moving off the brake testing rollers.
