# BELZONA REPAIR TO PIVOT PINS OF MILL

ID: 1057

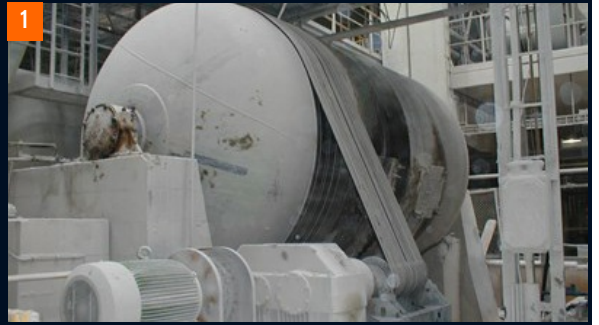
The two pivot pins supporting the crusher are damaged due to loading and working environment.

1. An overall view on the mill
2. An example of the excessive damage of the pins
3. Belzona 1111 ready to be machined
4. The pivot pin prepared for operation

Application was carried out in accordance with Belzona Know-How System Leaflet MPT-1. Hand portable lathe was used to machine the pivot pins.

The traditional repair using welding and subsequent grinding of the pivot pins took 5 weeks. The repair using Belzona took 3 days, resulting into significant savings.
