# COMPLETE REFURBISHMENT OF VACUUM PUMP WITH BELZONA

ID: 106

Large vacuum pump

Pulp and Paper Plant, Portugal

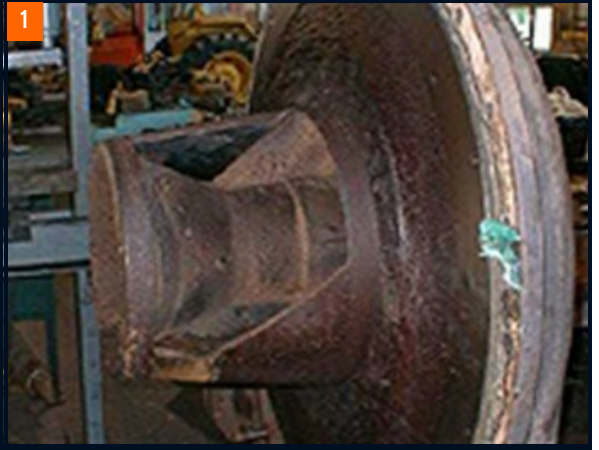
Extensive corrosion on all parts including rotor, end covers, and cones.

1. The degree of corrosion clearly evident on the head assembly
2. The refurbished head assembly
3. Application to rotor underway
4. The pump being re-assembled
