# BELZONA REBUILDS SHAFT & KEYWAY ON JAW CRUSHER

ID: 1064

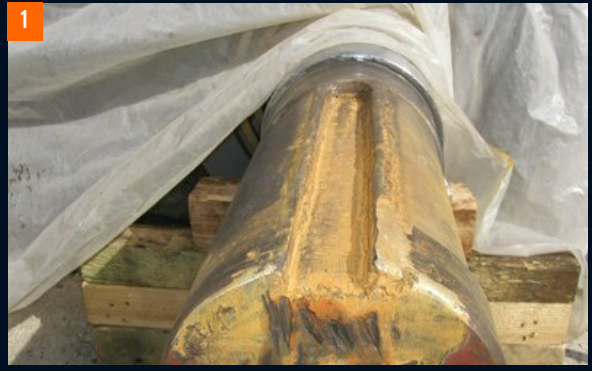
Shaft and keyway worn and damaged

1. Damaged shaft
2. Milling the keyway
3. Turning the Belzona 1111 rebuilt shaft
4. Shaft ready to transport back to customer
