# PROTECTION OF CARBIDE MIXTURE TRANSFER EQUIPMENT WITH BELZONA

ID: 1065

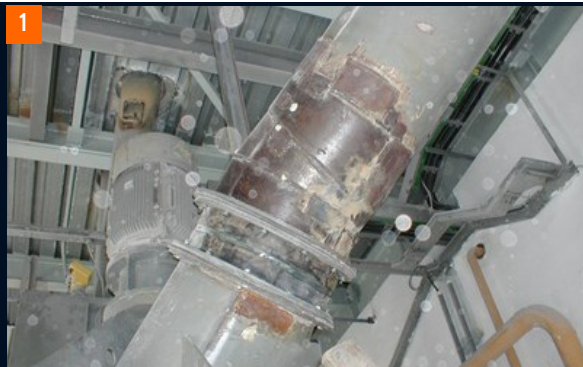
The highly abrasive carbide mixture wears tubes, pipe bends as well as the crusher itself.

1. Repair of the pipes was constantly required
2. The heavily damaged surface of the equipment
3. The application of Belzona 1811 to pipe bend
4. The pipe bend ready for operation
