# BELZONA SOLUTION FOR NEUTRALIZATION TOWER

ID: 1066

Reaction tower used in production of Vinyl Chloride.

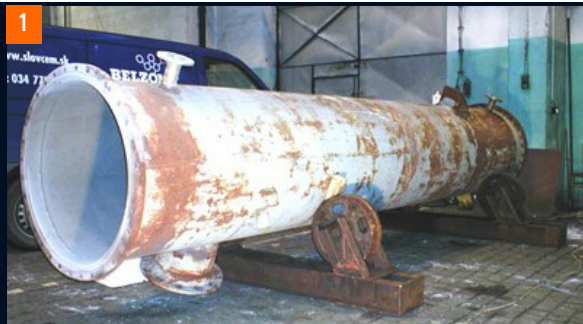
1. Neutralizing tower after blasting operation
2. Belzona 4331 applied
3. Ready to operate
