# BELZONA RESTORES SAFETY VALVE SEAL

ID: 1068

Damaged mating surface in the safety valve was allowing back-flow of water

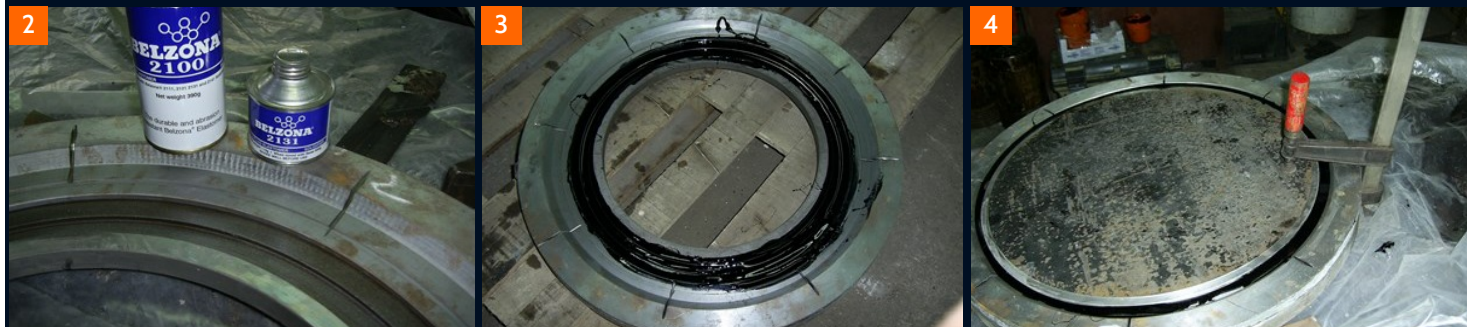
## PHOTOS

1. The safety valve plate
2. The inner and outer forming rings put on the valve plate
3. Belzona 2131 poured in the gap between two forming rings
4. The top forming plate clamped to form precise mating surface

Application was carried out in accordance with Belzona Know-How Leaflet GSS-1. Two forming rings(inner and outer to the valve diameter) were used to create the diameter profile and top plate used to form actual sealing face.

New valves were not available so the sealing surfaces were removed and Belzona® 2131 moulded to the original sealing profile. Belzona provided fast return to service. The alternative hot vulcanization required special equipment and extra time.
