# BELZONA REFURBISHMENT OF FLASH VESSELS USING INJECTION TECHNIQUES

ID: 107

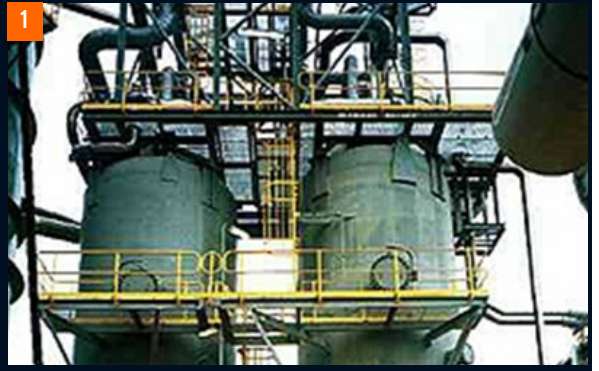
Vessel has a titanium insert in domed base and is also refractory brick lined. A void 1-20mm beneath insert allowed it to crack at start-up.

1. General View of two flash vessels on Train 2
2. Work underway from inside
3. Injection holes being drilled & tapped prior to injection from outside vessel

Application was carried out in accordance with Belzona System Leaflet GSS-9.
