# INJECTION OF BELZONA REPAIRS SHAFT

2.9 M diameter Butterfly Valve which controls the inlet water to the turbine.

Hydropower Station, Spain

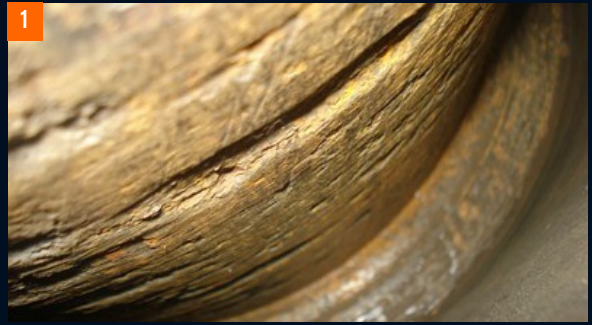
After more than 30 years working, the shaft had severe damage and loss of diameter causing water leaks

1. Original shaft damage
2. Heating the shaft with the former already installed
3. Injecting Belzona between the shaft and the former
4. Shaft rebuilt and protected at the same time

Application was carried out in accordance with Belzona Know-How System Leaflet MPT-2.

Replacement of the shaft would have needed a large part of the installation to be disassembled. With Belzona the customer saved these high costs and has restored shaft with improved corrosion resistance. Use of former enabled shaft to be accurately reformed in-situ.
