# BELZONA PROTECTS CHEMICAL CONTAINMENT AREAS

ID: 1071

Four chemical containments for polyester tanks filled with sodium hypochlorite

Coal Power Plant, Galicia, Spain

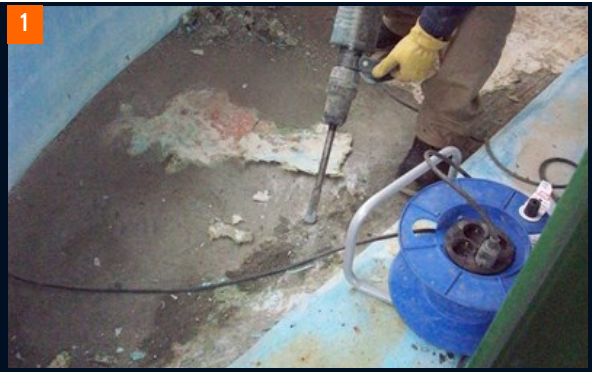
1. Removing the old coating
2. Blasting the surface to be coated
3. Applying the second layer of Belzona 4311 over the first coat
4. One of the containment areas after one month

Application was carried out in accordance with Belzona Know-How System Leaflet TCC-15.
