# BELZONA PROVIDES CONSISTENT SUPPLY OF PULVERIZED FUEL

ID: 1073

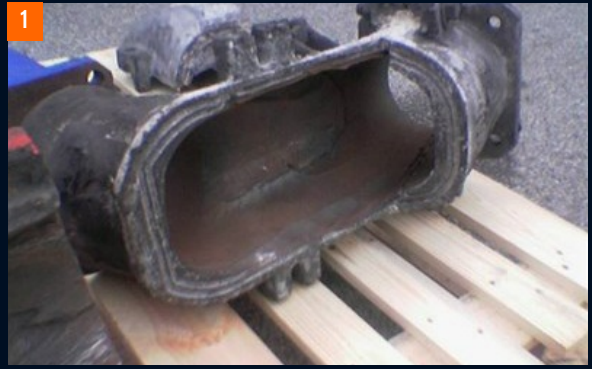
Dry abrasion from coal particles in pneumatic system causes wear at bends, curves and direction transitions.

1. A large bend
2. An L shaped curve
3. Completed cover
4. More bend covers protected with Belzona

Application was carried out in accordance with Belzona Know-How System Leaflet SHM-13. The replaceable covers for transition points are routinely filled with the Belzona.
