# BELZONA ELASTOMER MAKES MECHANICAL SEAL REFURBISHMENT EASY

Mechanical Seal from hydroelectric turbine

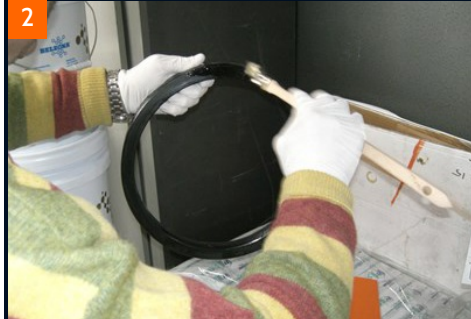
1. Protecting and blasting steel support
2. Rubber ring being Conditioned
3. Conditioner applied to metal support
4. Rubber ring bonded in place with Belzona Elastomer

Application carried out in accordance with Belzona Know-How System Leaflet GSS-2. Rubber ring bonded in place with Belzona® 2111 then re-machined to precise tolerance. Steel substrate is masked off and bond face grit blasted prior to bonding rubber ring in place with Belzona Elastomer.
