# BELZONA REPAIR TO VERTICAL EXPANSION JOINT COMES OF AGE

ID: 1076

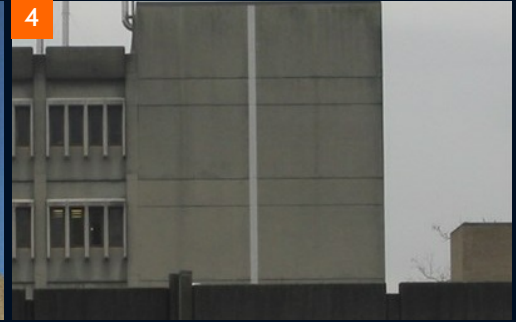
This application has been in service since 1987 (21 YEARS) without the need for any additional maintenance.

1. General view of 140-ft wall and problem joint.
2. The spalled edges of the concrete were rebuilt with Belzona 4111 before applying the Belzona 3111 (Flexible Membrane System).
3. Complete application - The final coat was tinted for a closer match to the concrete.
4. Picture taken in 2008 showing present condition of the 21-year-old application.
