# BELZONA FLEXIBLE MEMBRANE SEALS LEAKING CONCRETE DECK

ID: 1077

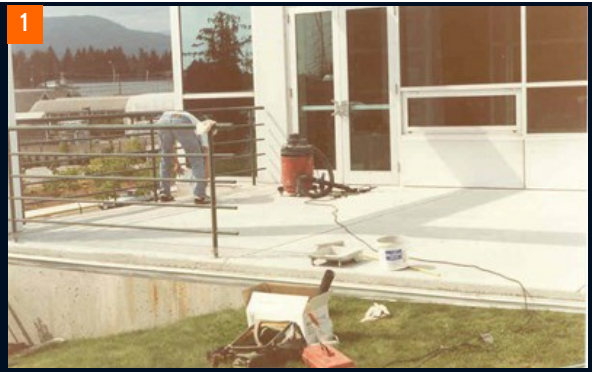
1. The deck prepared by pressure washing
2. After application of Belzona 3911 to concrete surfaces and Belzona 3921 Aluminum surfaces (window and door frames), Belzona 3111 was applied
3. View of deck taken in 2005 after 10 years of service

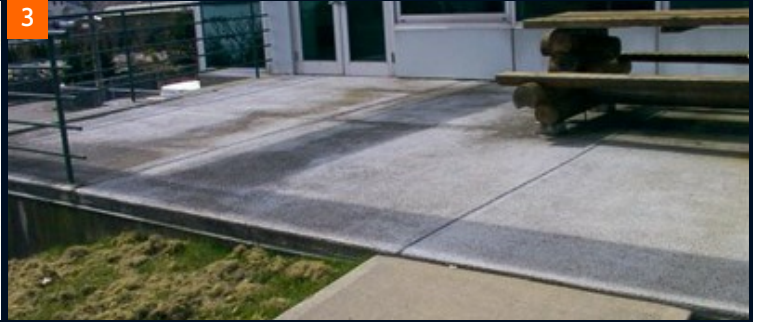
A recent check in 2008 reveals the deck coating to still be in service.
