# BELZONA REPAIRS LEAK IN HOT ACID PIPELINE

ID: 1079

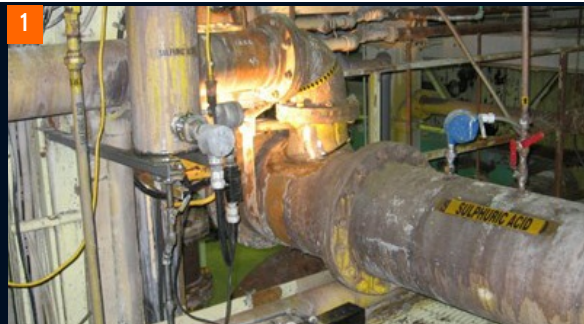
1. Overview of application situation
2. The hole in the valve is prepared by grinding
3. Completed application of 1st patch using Belzona 1311
4. Completed application with final patch of Belzona 4301 and steel plate bonded in place

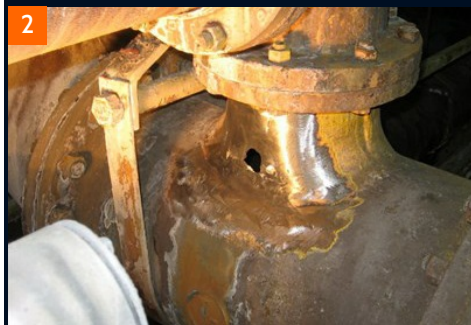
A cast "T" junction had developed a large hole and a replacement unit was several weeks away
