# BELZONA 1591 PROTECTS HEAT EXCHANGERS

ID: 108

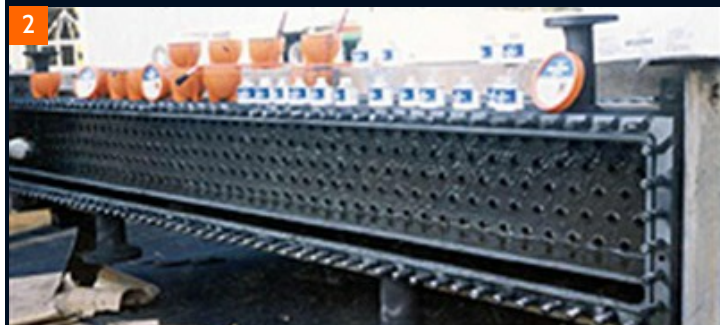
Severe erosion-corrosion of the tube sheet and end cover caused by the hot Hydrocarbon mixture.

1. The degree of erosion clearly evident on the end cover
2. Application of Belzona 1591 underway
3. Application to tube sheet completed. End cover awaiting coating.

Application was carried out in accordance with Belzona System Leaflet HEX-1
