# BELZONA ELASTOMER SEALS CONCRETE PARKING DECK

ID: 1080

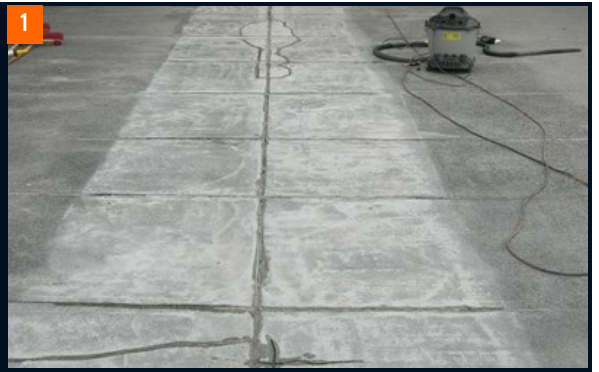
Various cracks and faulty seams on concrete parking deck.

1. All joints were ground clean to remove all traces of the failed material
2. All joints were conditioned with Belzona 2911 prior to injecting the Elastomer
3. Completed application with all the joints and cracks sealed

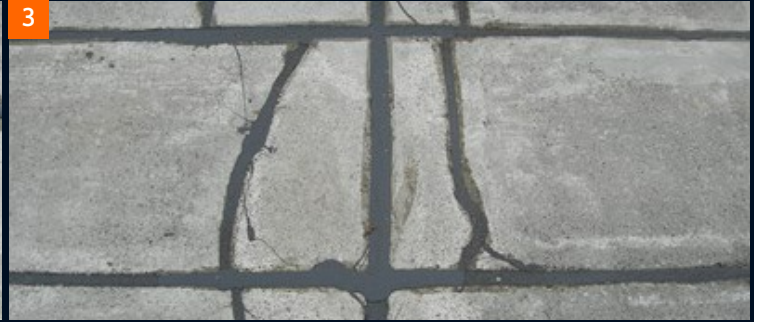
Heavy rains after the application had been completed revealed that the area was now completely water-tight.
