# BELZONA PROTECTS AERATOR IN WATER TREATMENT PLANT

ID: 1081

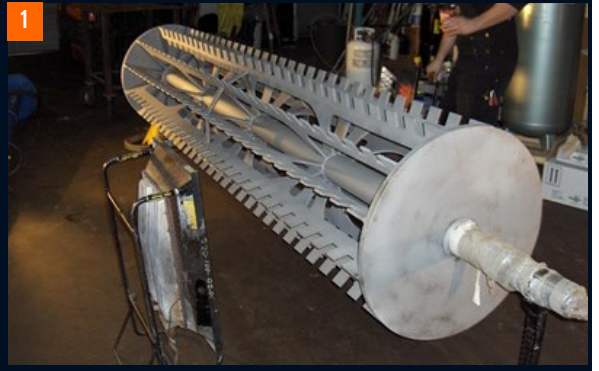
1. Completed aerator unit in the fabricating shop after grit blasting
2. Close up view of the equipment
3. Completed application, 2 coats of Belzona 1321
4. Protected aerator in service

The welded component required protection from bi-metallic corrosion

Application completed in accordance with Belzona Know-How System Leaflet SHM-11.
