# BELZONA REBUILDS CONTACT AREA ON RUDDER ASSEMBLY

ID: 1082

Rudder stock to rudder blade flange coupling

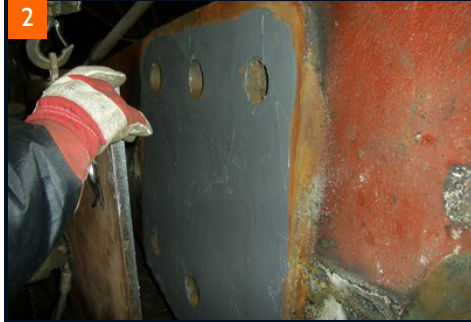
Lost contact area due to ingress of sea water after bolt connection failure

1. Badly corroded flange of the steering blade
2. Forming plate placed to form the flange
3. The blade ready to be assembled
4. Assembly ready to be bolted up
