# RESEATING NEW RUDDER BUSH WITH BELZONA

ID: 1083

Installation of new pintle bearing bush in worn pintle bearing housing.

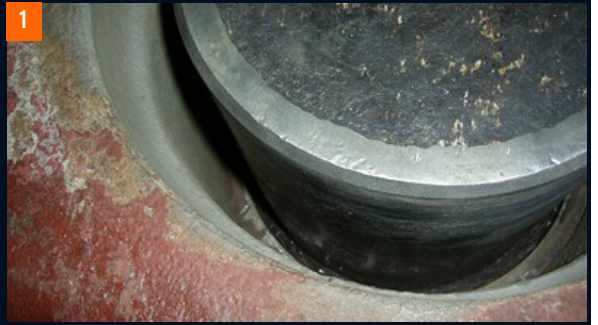
Corrosion damages and wear led to increased annular space between the bush and its housing and irregular form of the bush housing.

1. The housing prepared by blasting and ready for bush assembly.
2. The new bearing bush prepared with thread profile and longitudinal channels to accommodate plastic pipes for injection and to serve as locking keys to prevent bush rotation.
3. Sealing the bottom of the new bush with Belzona 1221.
4. Completed application. Belzona 1321 completely filled annular space. Pintle with metal shims were used for bush alignment.
