# POWER COMPANY APPROVES THE BELZONA SOLUTION

Protection of an impeller from cooling water system.

Nuclear Power Plant, France

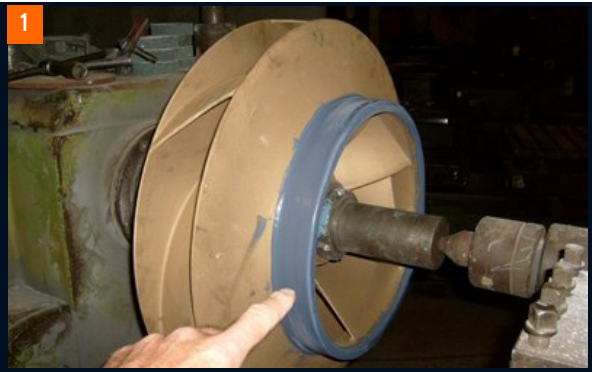
Erosion-Corrosion caused by sea water.

1. Commencement of application with Belzona 1321 applied to wear ring
2. Application of the first coat of Belzona 1341
3. Completed application with wear ring machined to size

Application carried out in accordance with Belzona System Leaflet CEP-3. Impeller surfaces protected with Belzona® 1341 and Belzona® 1321 applied to wear ring and machined to size.
