# BELZONA PROTECTS CLARIFIER

ID: 1088

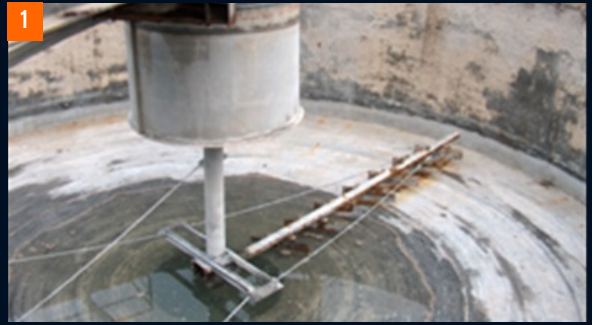
Concrete damaged by erosion and abrasion led to underground leakages with contaminated water.

1. Before Belzona
2. Application of Belzona 4111
3. Application of Belzona 5811
4. Completed application
