# BELZONA 1391 PROTECTS CATALYTIC CRACKER

ID: 109

The light ends tower within the Catalytic Cracker.

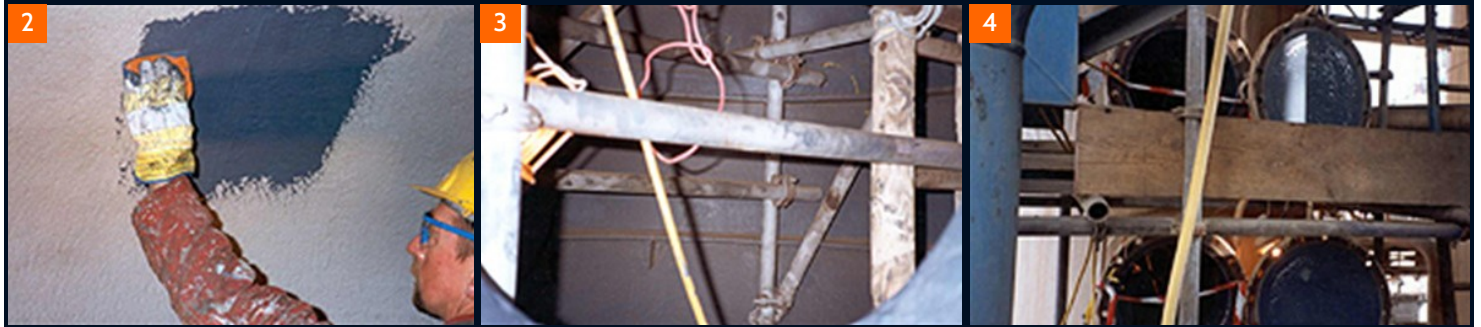
Extensive erosion-corrosion on the shell wall caused by the hot hydrocarbon mixture.

1. General view of the application site
2. Application of Belzona 1391 underway
3. View through the manway showing confined working conditions
4. Application completed with hatch covers also coated with Belzona 1391

Application was carried out in accordance with Belzona System Leaflet TCC-5.

Metal loss, if allowed to continue, would have led to the structural integrity of the wall being compromised. Repair or replacement would have led to a major shutdown of the refinery with its major associated loss of revenues. The Belzona products lent themselves to application within the confines of the tower and allowed its return to service with minimal downtime.
