# BELZONA PROVIDES CAVITATION PROTECTION TO PUMP IMPELLER

ID: 1091

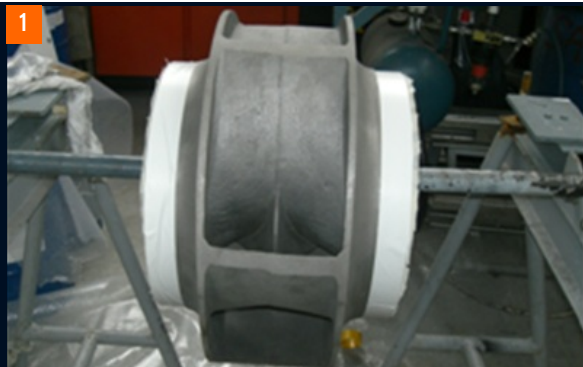
1. Blasted Surface
2. Coated with Belzona 1341
3. First coat of Belzona 2141 (black) applied
4. Application completed with a second coat of Belzona 2141 (green)
