# BELZONA REPAIRS INJECTION PIPES IN FGD UNIT

ID: 1093

Lime Slurry Injection pipeline within the wet FGD scrubber

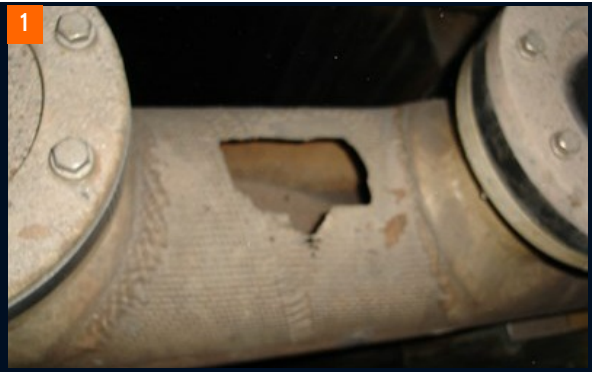
Limestone slurry is injected through the nozzles. This falls on the GRP pipeline connecting the nozzles causing holes

1. Typical damage to the pipework
2. Surface preparation being carried out
3. Application being carried out
4. Completed application
