# BELZONA GETS TRACTOR BACK ON TRACKS

ID: 1094

Abrasion of rubber on inside surface of tracks

Rubber tractor tracks

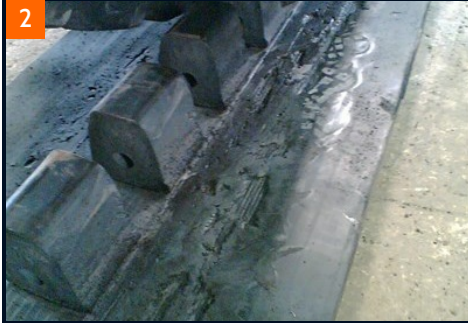
1. General view of track before repair
2. Close up of damaged area
3. After repair
4. Back on track

Application was carried out in accordance with Belzona Know-how System Leaflet SHM-1.

Belzona 2111 (D&A Hi-Build Elastomer)
